TITLE: AGUSTA Experience on Damage Tolerance  
Evaluation of Helicopter Components

## AGUSTA Experience on Damage Tolerance Evaluation of Helicopter Components

Ugo Mariani – Fatigue Office  
Luigi Candiani – Accidents Investigation Office

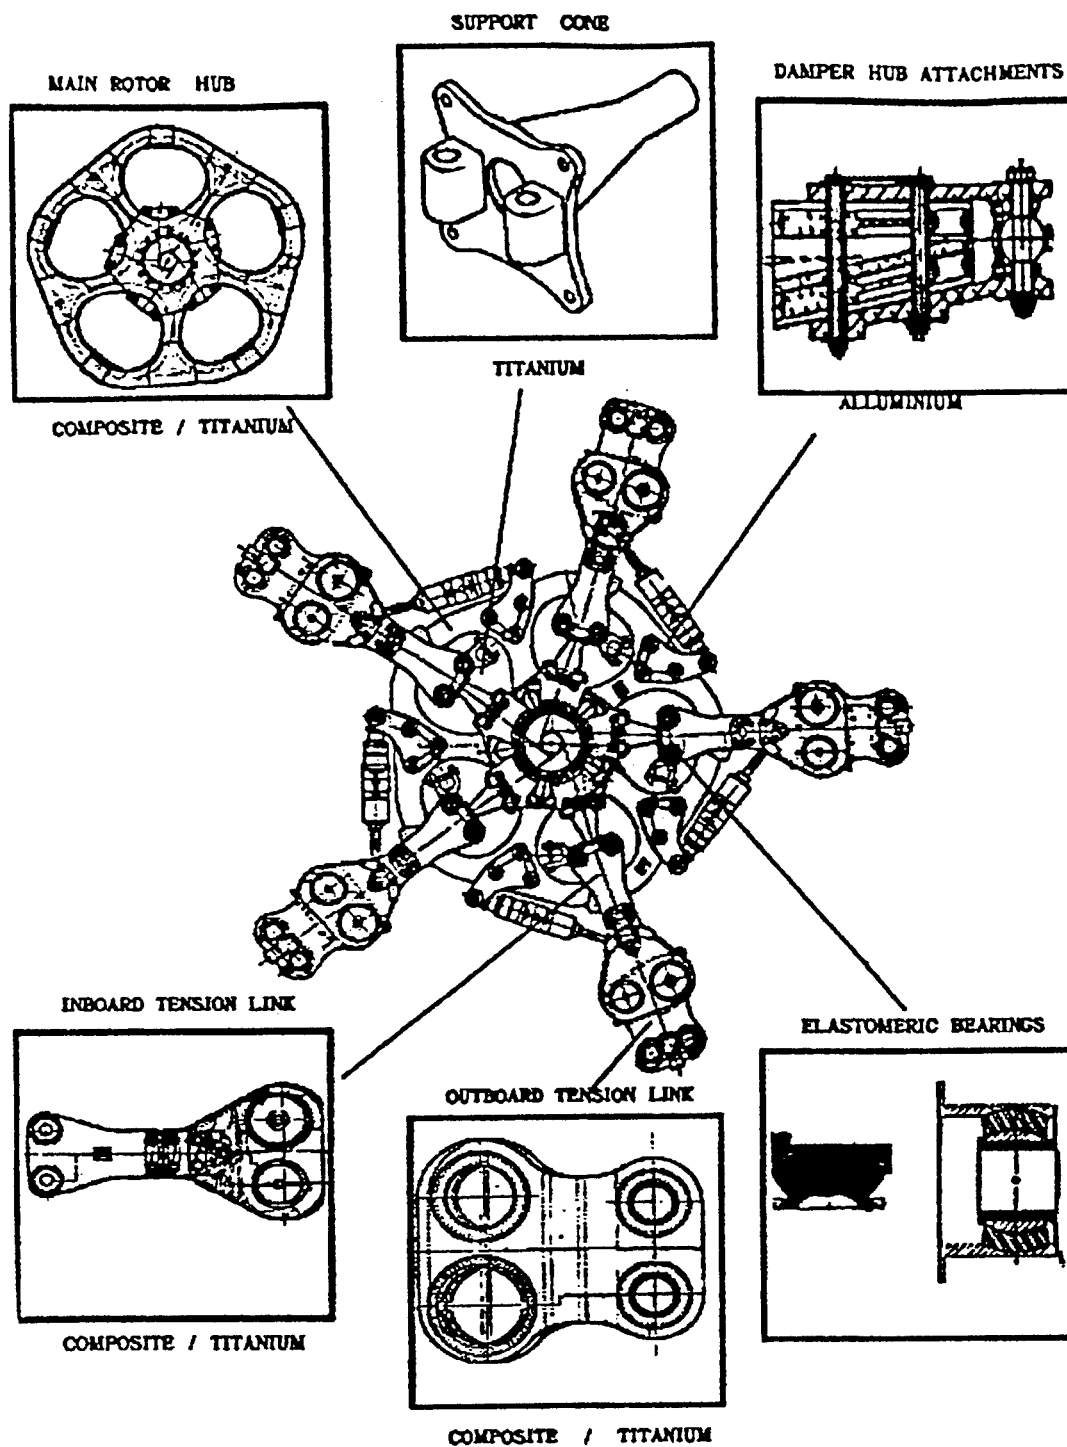
Figure 1 points out the Main Rotor Head components evaluated for Damage Tolerance capabilities.

Figure 1 - EH101 Main Rotor Head - Components verified for Damage Tolerance capabilities.

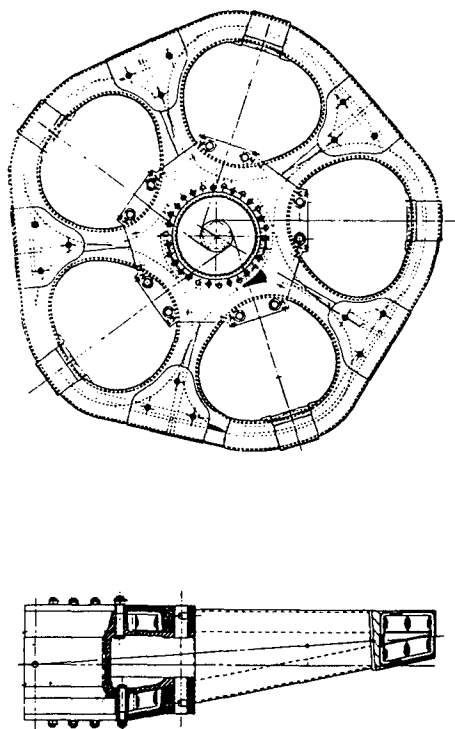
The M.R. Hub, figure 2, assures connection of the 5 blades and transfers the loads to the mast through a splined coupling. It is a hybrid metal-composite structure made by a titanium core and 10 small plus 2 large carbon fibre-epoxy loop windings enclosed by an external wrapped glass-epoxy box. The hub is a 125°C autoclave cured component.

Figure 2 - Main Rotor Hub

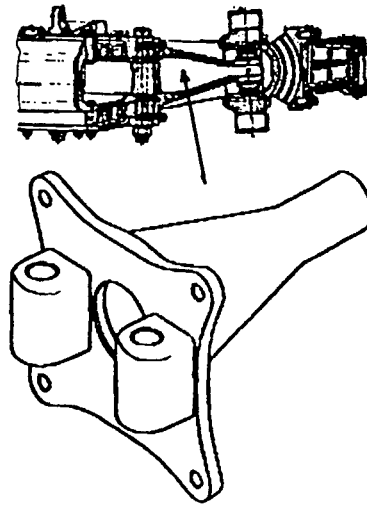
The M.R. Support Cone connects the Pitch Change Arm to the Rotor Hub. It is made by Titanium with a vulcanised Elastomeric Centering Bearing, which allows the pitch movement of the blade, figure 8. The Support Cone is connected to the Hub core via two Special Bolts and four Stud Bolts.

Figure 8 - M.R. Support Cone

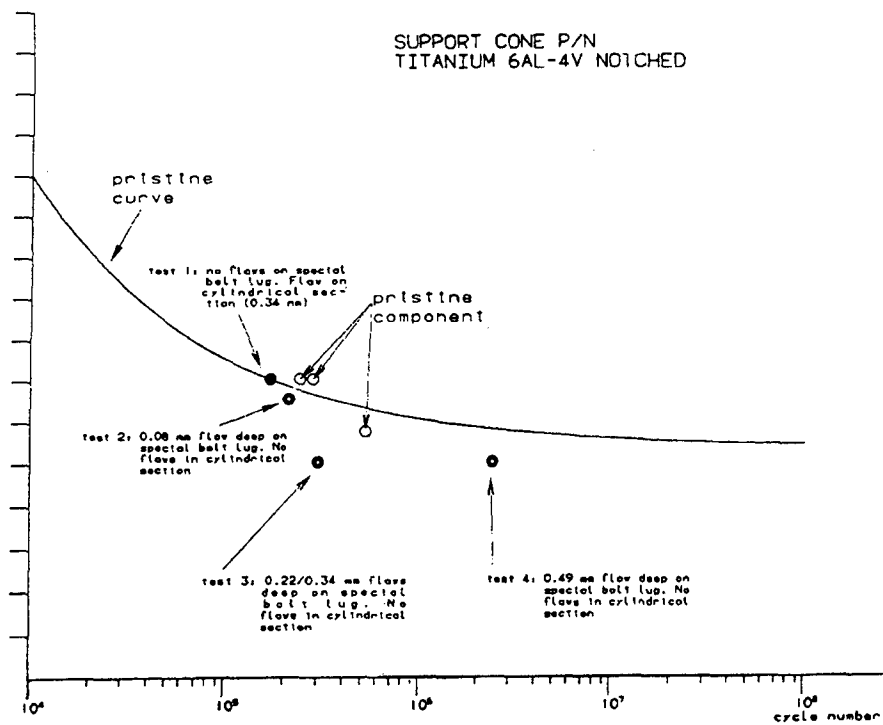
The rogue flaw in the lug reduces the fatigue strength of the pristine components by 1.25, the flaws in the other sections did not show relevant fatigue strength reduction. The Enhanced Safe Life evaluation for surface flaws in the lug did not show any additional fatigue life reduction. Figure 10 shows the fatigue test data.

Figure 10 - M.R. Hub Support Cone Flaw Tolerance Data

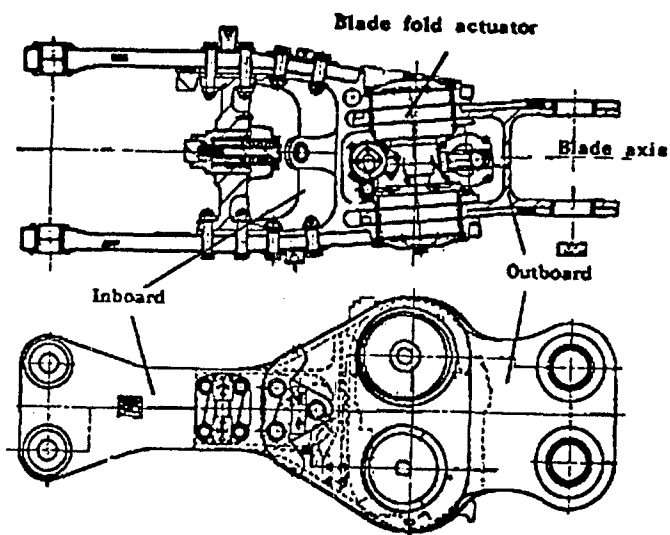
Figure 11 shows the two components, designed to allow blade folding for the Navy requirements.

Figure 11 - M.R. Inboard and Outboard Tension Links

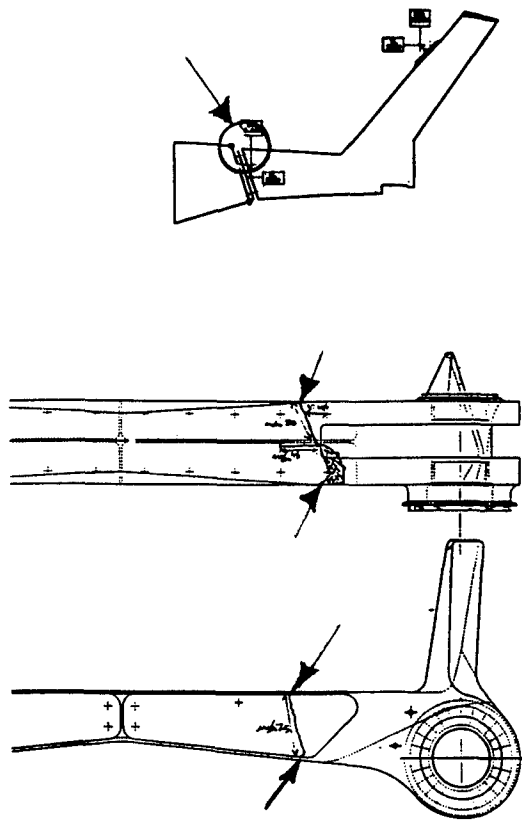
The most relevant evidences for damage tolerance were provided by the spectrum test of the Naval subcomponent, made by the Rear Folding Beams and the last bays of the fuselage. This configuration provides a foldable joint with the Tail Unit structure. In the safe life test a rig failure occurred during the folding phase, overloading the Rear Upper Folding Beam which failed with a large crack which cut through the Beam critical section, near the Actuator Lug, figure 18. The test was continued for the flight loading phase proving 50 hours of fail safe capability, with a life safety factor of 4. The crack is easily detectable by visual inspection while the Tail Unit is folded and this has an average occurrence of 4 hours in the usage spectrum.

Figure 18 – Naval Rear Fuselage D.T. of Folding Beams
